Manhole Inspection Summary

Manhole # S07WW_007MH

Insp Date: 1/12/09 11:29 AM

Location Address: **3600 LIBERTY HEIGHTS AVE**

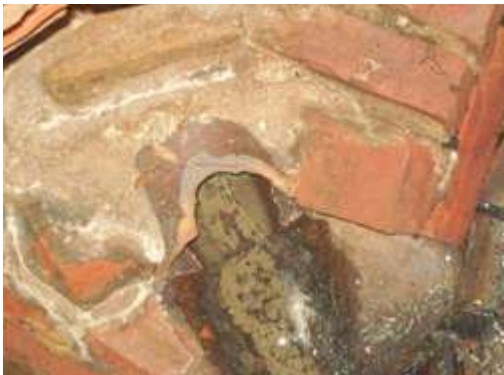
Defect 5

PIPE SEAL BROKEN

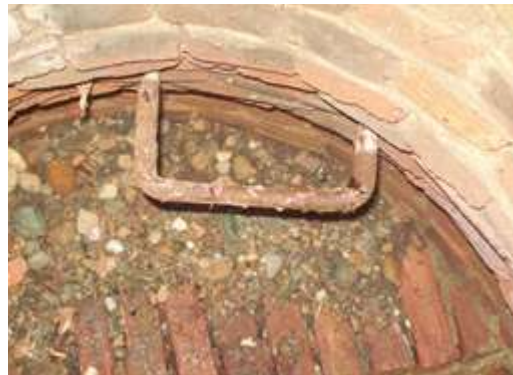
Defect 2

Count: **1** Missing: **0** ☒ **Corroded**

CORRODED STEPS

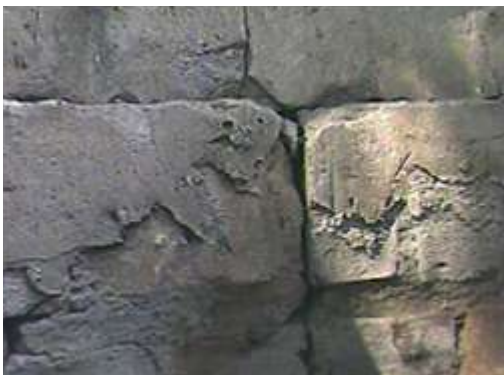
Defect 1

Condition: ☐ Sound ☒ **Cracked** ☐ Root Intrusion ☒ **Loose Brick** ☒ **Deteriorated**

CRACKED CORBEL, LOOSE BRICKS
AND DETERIORATED

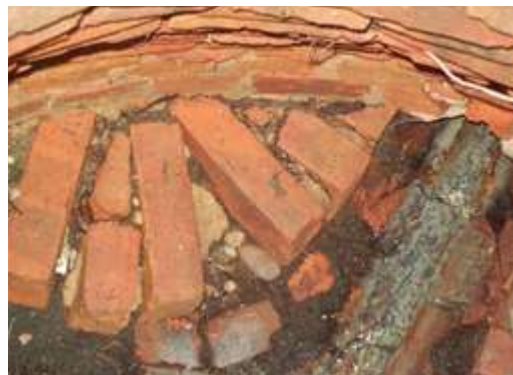
Defect 4

debris in channel

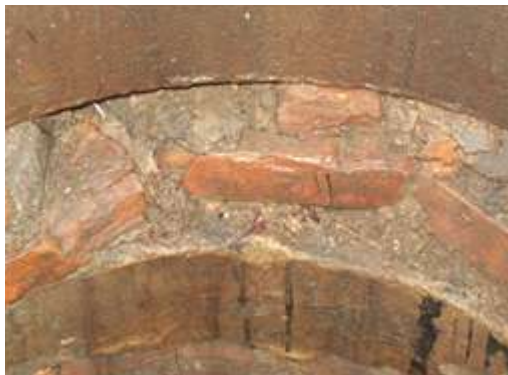
Defect 3

cracked corbel

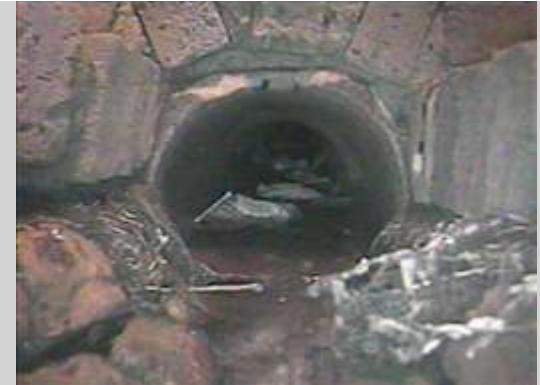
12 O'Clock Outflow

Pipe Height: (in.) Direct
Pipe Material: **Clay** ☐ Pipe Lined
Invert Depth: **6.10** (ft.) Flow Characteristics: **Slow**
Deposits: ☐ None ☐ Mud ☐ Sludge ☒ **Debris** ☐ Grease
Silt Depth: **2** (in.) Deposits Extent: **Medium**
Infiltration: **None** Pipe Seal Cond: **Broken**

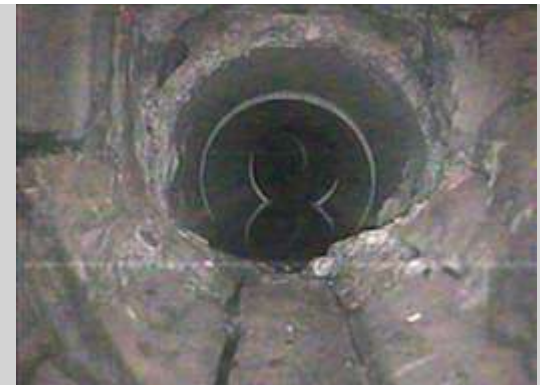
6 O'Clock Inflow

Pipe Height: (in.) Direct
Pipe Material: **Clay** ☐ Pipe Lined
Invert Depth: **6.06** (ft.) Flow Characteristics: **Slow**
Deposits: ☒ **None** ☐ Mud ☐ Sludge ☐ Debris ☐ Grease
Silt Depth: (in.) Deposits Extent:
Infiltration: **None** Pipe Seal Cond: **Cracked**

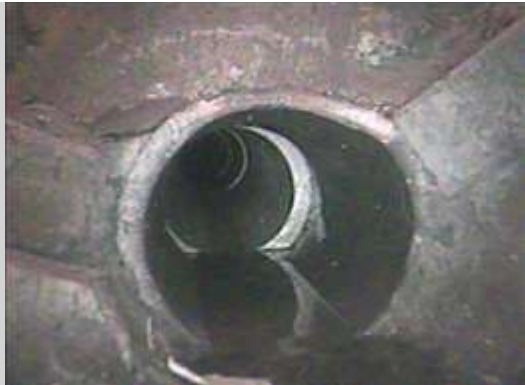
7 O'Clock Inflow

DEBRIS IN CHANNEL

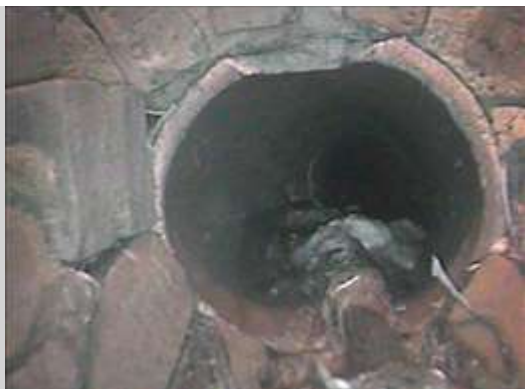
9 O'Clock Inflow

DEBRIS IN CHANNEL

Deposits: ☐ None ☐ Mud ☐ Sludge ☒ **Debris** ☐ Grease

Silt Depth: **2** (in.) Deposits Extent: **Medium**

Pipe Seal Cond: **Broken**
